# Appendix 4.1.B – Portbury Wharf flood risk review

Wessex Water

# Portbury Wall Risk & Effect of Tidal Overtopping

Client :	Wessex Water Services Ltd - Project D9794C
Project :	Overtopping Report
Title :	Risk & Effect of Tidal Overtopping

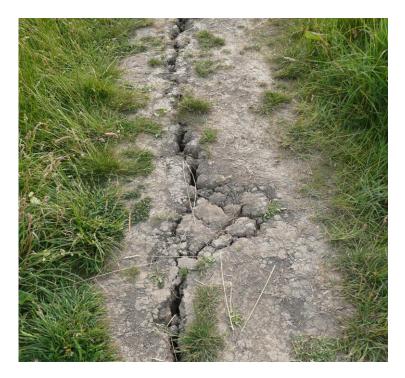
At the time of the most recent inspection of the sea wall in September 2016 the wall was considered to be in reasonable condition. No significant shrinkage cracking of the structure was evident at the time, although longitudinal cracking caused by prolonged dry weather had been recorded on previous inspections. See Figure 1. Longitudinal cracking as witnessed on earlier inspections is not considered to be critical because, in contrast with any transverse cracking, intrusion by tidal water is unlikely unless the wall is overtopped.

Figure 1. Longitudinal Cracking on crest of wall in dry conditions

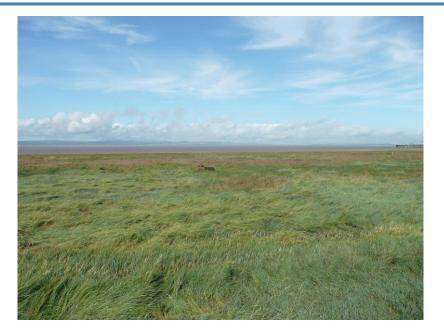
The wall enjoys a significant degree of protection from wave attack due to a frontage of extensive saltmarsh with a level of approximately +13.20mCD (See Figure 2). The average level of the wall crest is approximately +14.77mCD. The average height of the wall above saltmarsh level is therefore only 1.57m.

Figure 2. Salt marsh on seaward side of the wall

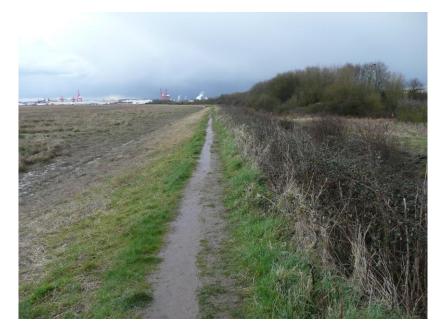
With the exception of the crest, the wall is well covered by vegetation comprising mixed grasses, wild plants and, on the landward slope, scrub (See Figure 3).

Figure 3 Picture showing scrub on landward side of the wall

The vegetation is expected to provide a reasonable level of resistance to erosion in the event of tidal overtopping of modest depth and duration.

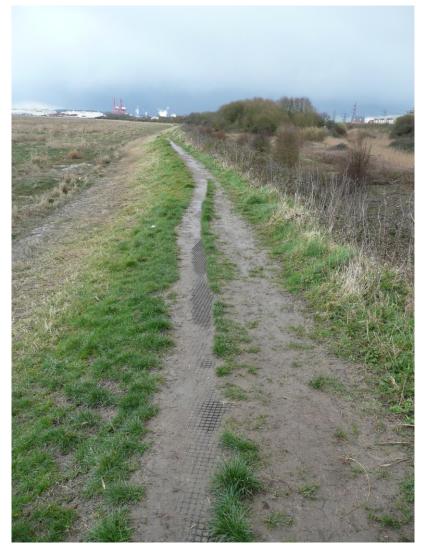
In contrast to the slopes, the crest of the wall in places is devoid of vegetation due to erosion by pedestrian traffic. Pedestrian traffic, and hence surface erosion, has in recent years increased significantly as the extent of local housing development and occupancy nears completion. The foot tread erosion can be clearly seen in Figure 3 above. In places surface erosion has exposed a plastic reinforcing membrane (geogrid) along the western half of the wall (see Figure 4).

Figure 4. Exposed Geogrid on crest of wall

The depth of erosion has been limited by the near surface layer of the geogrid, but it is not thought that the geogrid is continuous over the whole length of the wall. Additional work may be necessary in future if the crest erosion becomes significant. An effect of surface erosion is that the clay structure dries more quickly during prolonged warm dry weather resulting in the propagation of localised linear shrinkage cracks to a depth of up to half a metre. At present,

neither the surface erosion nor the cracking are considered to be a threat to the stability of the wall, but this may change if erosion or cracking is increased.

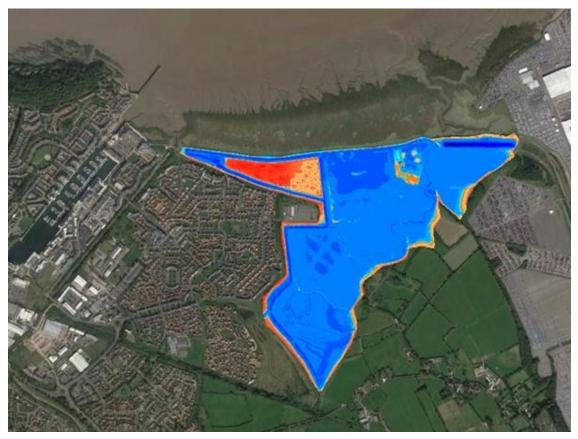
extend beyond the maximum limits shown in Figure 10, but penetration of these areas by flood water is restricted by the size of physical structures, such as culverts, and relatively small gaps in counter walls, or between areas of raised land. Because the duration of overtopping of the seawall is limited by a period about high water there may not be sufficient time for these additional areas to absorb a substantial volume of flood water. In consequence, once the whole available area is flooded the flood level within will rise quickly with only very small increasing area until flood level and tide level are the same and subsequent flood level matches the increasing tide level.

Note: Area in Blue would be susceptible to an overtopping/flood event Ground level in areas coloured red or orange are lower than the general land level.

#### Figure.10 Potential Maximum Flood Area

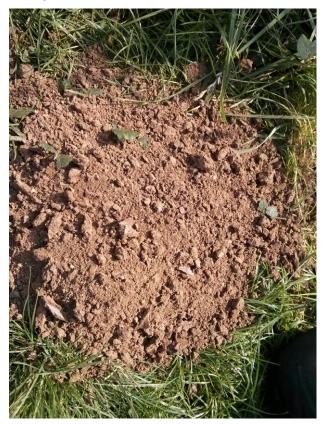
horizontal position either fell out freely, or crumbled to a mixture of crumbs and dust when disturbed. See Figure 11.

Figure 11. Loose soil recovered from upper 1m of wall

The lack of cohesion suggests that if the soil in the wall structure is exposed during overtopping erosion would be likely and possibly quite rapid. However, it is considered unlikely that erosion would continue to a significant depth below that of the salt marsh which would therefore define the maximum depth of flow entering a breach. The soil encountered in the boreholes increased in plasticity with greater depth to the extent that soil below about 1m depth could be hand rolled into a string of about 5mm diameter.

It is possible that the moisture content of the upper metre of the wall at the time of investigation in mid-September was exceptionally low, being at the end of a relatively dry summer, but if such dryness is characteristic of the late summer early autumn period it is likely to coincide with the equinoxial tides when the risk of overtopping logically may be greatest, but as stated previously, the risk of coincidence of spring Tides and surge conditions appears to be low. This is supported by the historical records, which show that all but one of the recorded historical tides that have exceeded the wall height occurred during the winter period. See analysis of tide heights in Section 3 above.

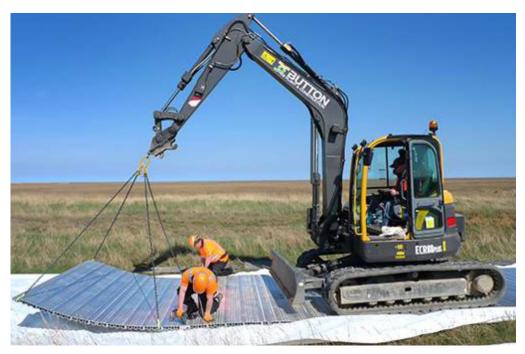
Except when exceptionally dry, the salt marsh is too weak to support the repeated passage of heavy traffic. The problem might be overcome by the use of low ground pressure plant, such as tractor and trailer with balloon tyres running on the saltmarsh, but success could not be guaranteed and the risk of damage to the saltmarsh would be high. The salt marsh is a SSSI and hence avoidance of damage would be necessary.

Figure 12 Example of Trackway temporary road across a SSSI

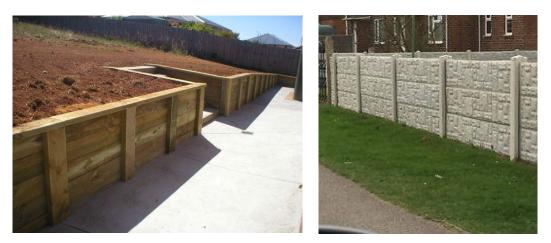
Figure 13. Wooden and Concrete Post and Plank Systems

The advantage of post and plank construction, especially a single wall design, is that the components are relatively lightweight and do not require substantial mechanical plant to transport materials and install posts. Transport along the wall could be manual using a wheeled cart, or a mechanical tracked barrow as sown in Figure.14, or 4-wheel drive dumper, might also be suitable for moving soil in the profile raising option discussed in 5.1 above.

The components of a post and plank wall are not heavy and in consequence the construction could be achieved by a combination of relatively lightweight mechanical plant and manual labour. The risk of damage to the local environment would therefore be small relative to bulk earthmoving, but objections might arise on aesthetic grounds. Of the post and plank forms considered, a combination of concrete posts and timber planks is likely to be most acceptable, but would be less durable that steel. It is also estimated to be the least expensive.

If increasing the height of the existing sea wall is the favoured method of increasing protection to the STW, it is recommended that the initial focus be on a concrete post and wooden plank wall and that consultations be held with key stakeholders to determine acceptability and level of objection if any.

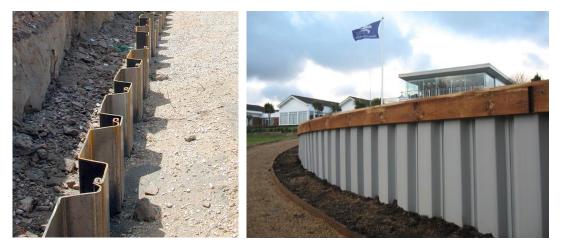
The use of interlocking trench sheeting is a common method of construction for a vertical wall, usually to retain soil. See Figure 15. Sheeting is most commonly steel, but is also available in PVC, the latter being lighter and less expensive, but less strong. Both materials are strong enough to be driven mechanically subject to the use of a suitable pile cap. Steel would require periodic maintenance, but unless damaged, PVC would not. A capping would be required to add rigidity and to maintain alignment. A timber capping would improve appearance and is likely to be more acceptable to the public, but may be more costly. Subject to material strength and wall height, a timber or steel waling might also be required, but for a maximum wall height of only about 1.5m this is may not be essential.

Figure 15. Steel and PVC interlocking trench sheeters

Although steel sheet walls are common in the construction of sea defences, given the sensitive nature of the local environment and the close proximity to people walking for leisure, the use of steel may be resisted by planners and environmental groups. PVC sheeters may be more acceptable if formed in material of a suitable colour. PVC sheeters would be more vulnerable to damage than steel, but as the site is not normally accessible to mechanised vehicles, the risk is probably small. Unlike steel, PVC would not require periodic maintenance, but the period between maintenance for steel is would be long, perhaps requiring recoating at intervals in excess of 10 years.

Construction using driven corrugated PVC or cement fibre sheets, or steel sheet piles, may require heavier mechanical equipment than post a post and plank wall, but the risk of damage to the environment could be minimised by various means.

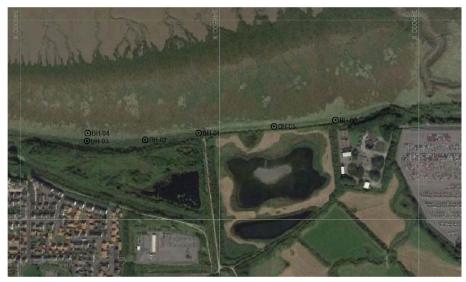
Appendix 2: Borehole Layout Drawing

**BH Location plan**
